**SAFETY ADVISORY # 13-195****Dutchmen Cooktop Propane Line**

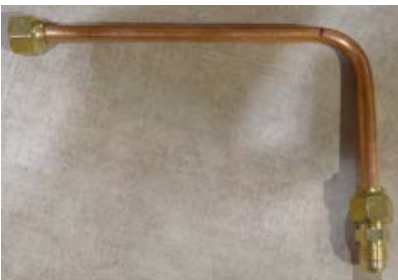
**Parts Required per Unit: # 268096 - 3/8" Copper Tubing 15" Long**

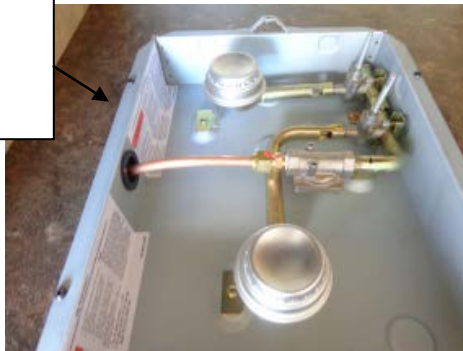
**Figure 1**  
**CORRECT**

Flexible propane hose connects outside the range burner box.

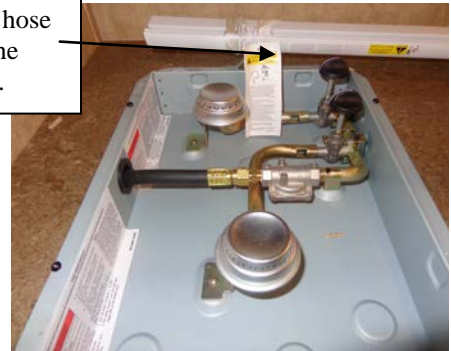
**Figure 2**  
**INCORRECT**

Dutchmen Manufacturing, Inc. is conducting a voluntary RECALL notification campaign in accordance with the National Traffic and Motor Vehicle Safety Act. It has been decided the vehicles subject to this recall campaign have a flexible non-metallic propane supply hose installed inside the burner box of the cooktop. In certain conditions, the heat from the range burner may cause the hose to melt and leak propane leading to an increased risk of fire, personal injury and property damage. This advisory explains how to correct the problem.

Flexible propane hose connects inside the range burner box.

- Step 1** Disconnect the flexible propane supply hose from the cooktop regulator.
- Step 2** Inspect the propane hose for damage. Replace hose if necessary.
- Step 3** Insert the new copper tubing through the grommet and attach the copper tubing to the range regulator using 5/8 wrench as a back up and to the flexible supply hose. See figure 3 and 4.
